Home Detective Property Inspections

xxxxxxxxxxxxxxxxxxxx, Olathe KS, 66061
Inspection prepared for: xxxxxxx xxxxxxx
Agent: xxxxxxxxxxx -

Inspection Date: 3/2/2012 Time: 8:00 AM
Age: 14 yrs Size: 4,192 sq ft
Weather: Rain/Snow/42 degrees

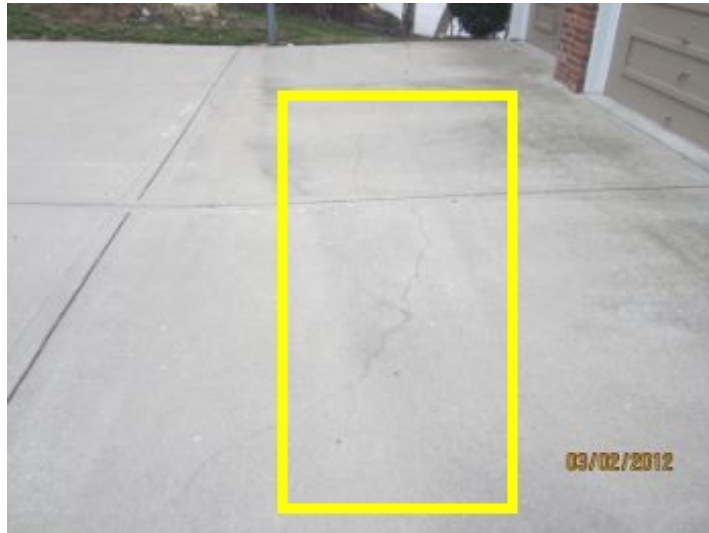
Minor settlement or "hairline" cracks in driveways are normal to properties of any age. They should, however, be monitored for expansion and sealed as necessary.

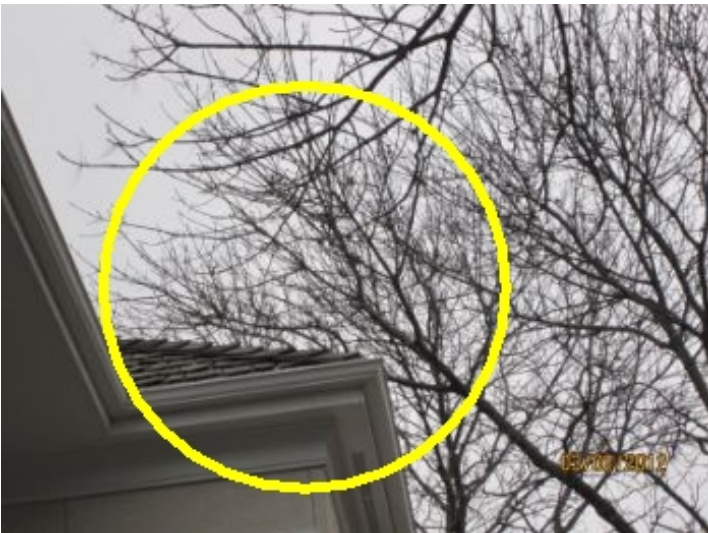
Tree limbs within 10 feet of roof should be trimmed away to provide air and sunlight to roof, while minimizing debris & dampness.

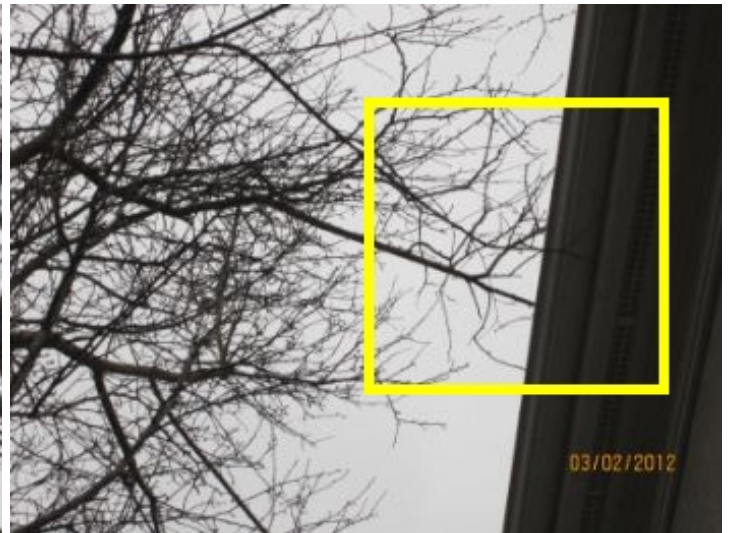
Tree limbs within 10 feet of roof should be trimmed away to provide air and sunlight to roof, while minimizing debris & dampness.

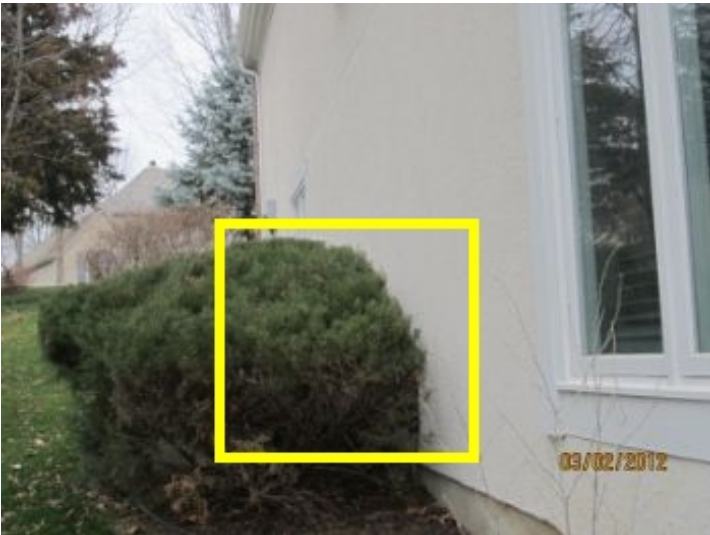
Prune or remove any plants that are in contact or proximity to home to eliminate pathways of wood destroying insects.

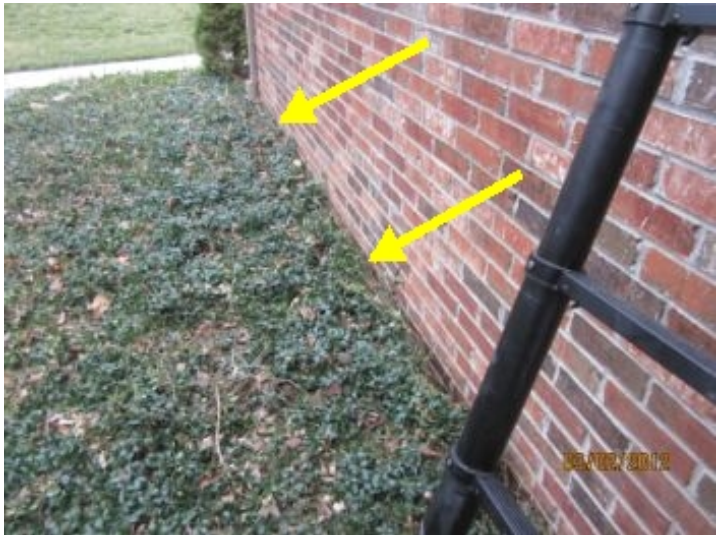
Recommend removal of foliage and ensure 2 to 3 inches spacing between brick siding and ground cover

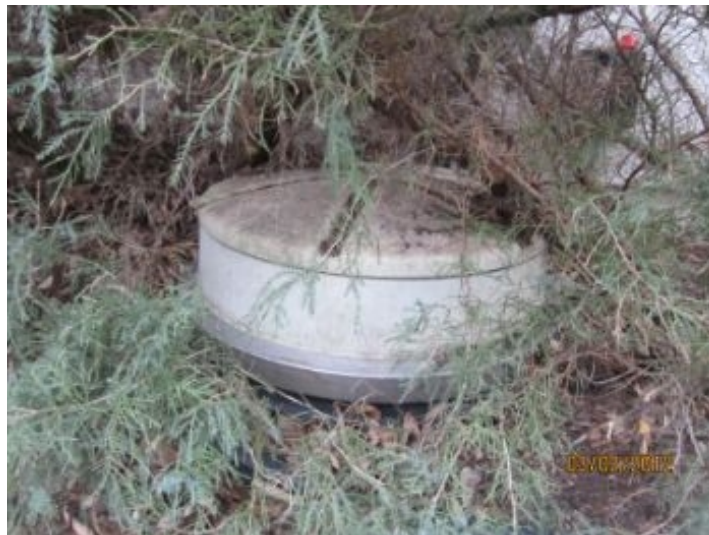
Noted: Lift station for sewer line to pump sewage up to the main sewer line. This is not a part of the home inspection.
